Manhole Inspection Summary

Manhole # S57C__017MH

Insp Date: **6/25/08 2:04 PM**

Location Address: **45 n kresson st**

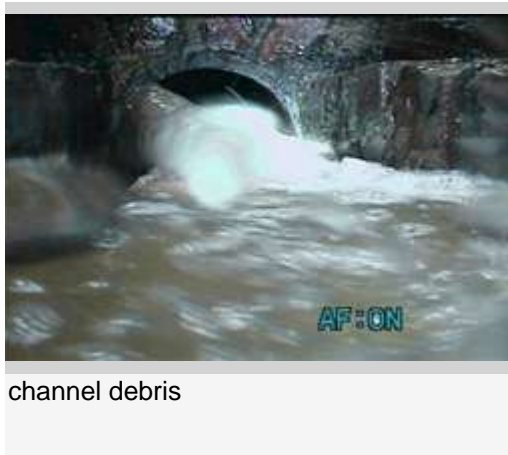
Defect 3

Condition: ☐ Sound ☐ Cracked ☐ Root Intrusion ☐ Deteriorated ☐ Leaks ☒ Debris

channel debris

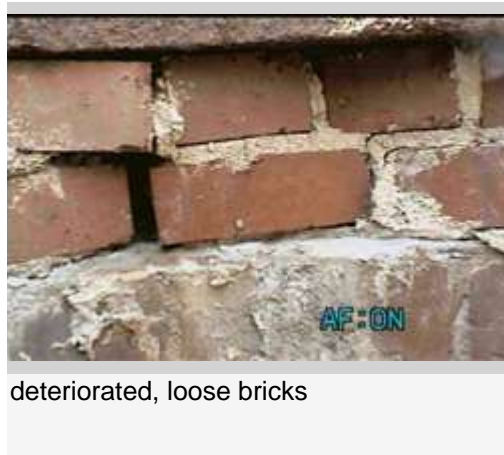
Defect 2

Condition: ☐ Sound ☐ Cracked ☐ Root Intrusion ☒ Loose Brick ☒ Deteriorated

Infiltration: ☐ None ☒ Joint ☐ Cracks ☒ Mortar ☐ Roots ☐ Wall

deteriorated, loose bricks

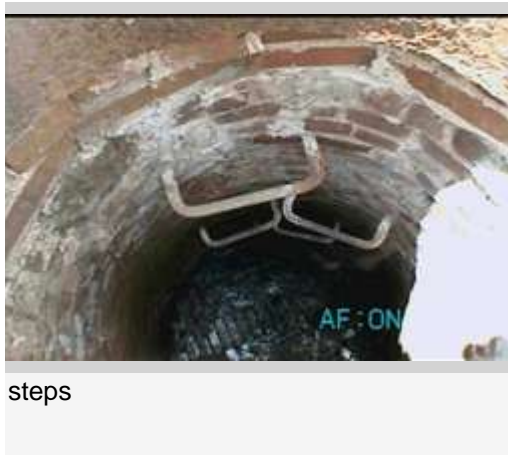
Defect 1

Count: **6** Missing: **0** ☒ Corroded

steps

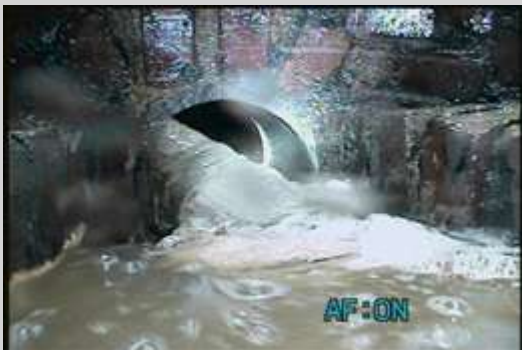
12 O'Clock Outflow

8 in. Circular Gravity Sewer
Pipe Out @ 12 OClock

Deposits: ☐ None ☐ Mud ☐ Sludge ☒ Debris ☐ Grease

Silt Depth: 5 (in.) Deposits Extent: Medium
